ANNUAL SITE INSPECTION REPORT

AUGUST 2001

BAILEY SUPERFUND SITE

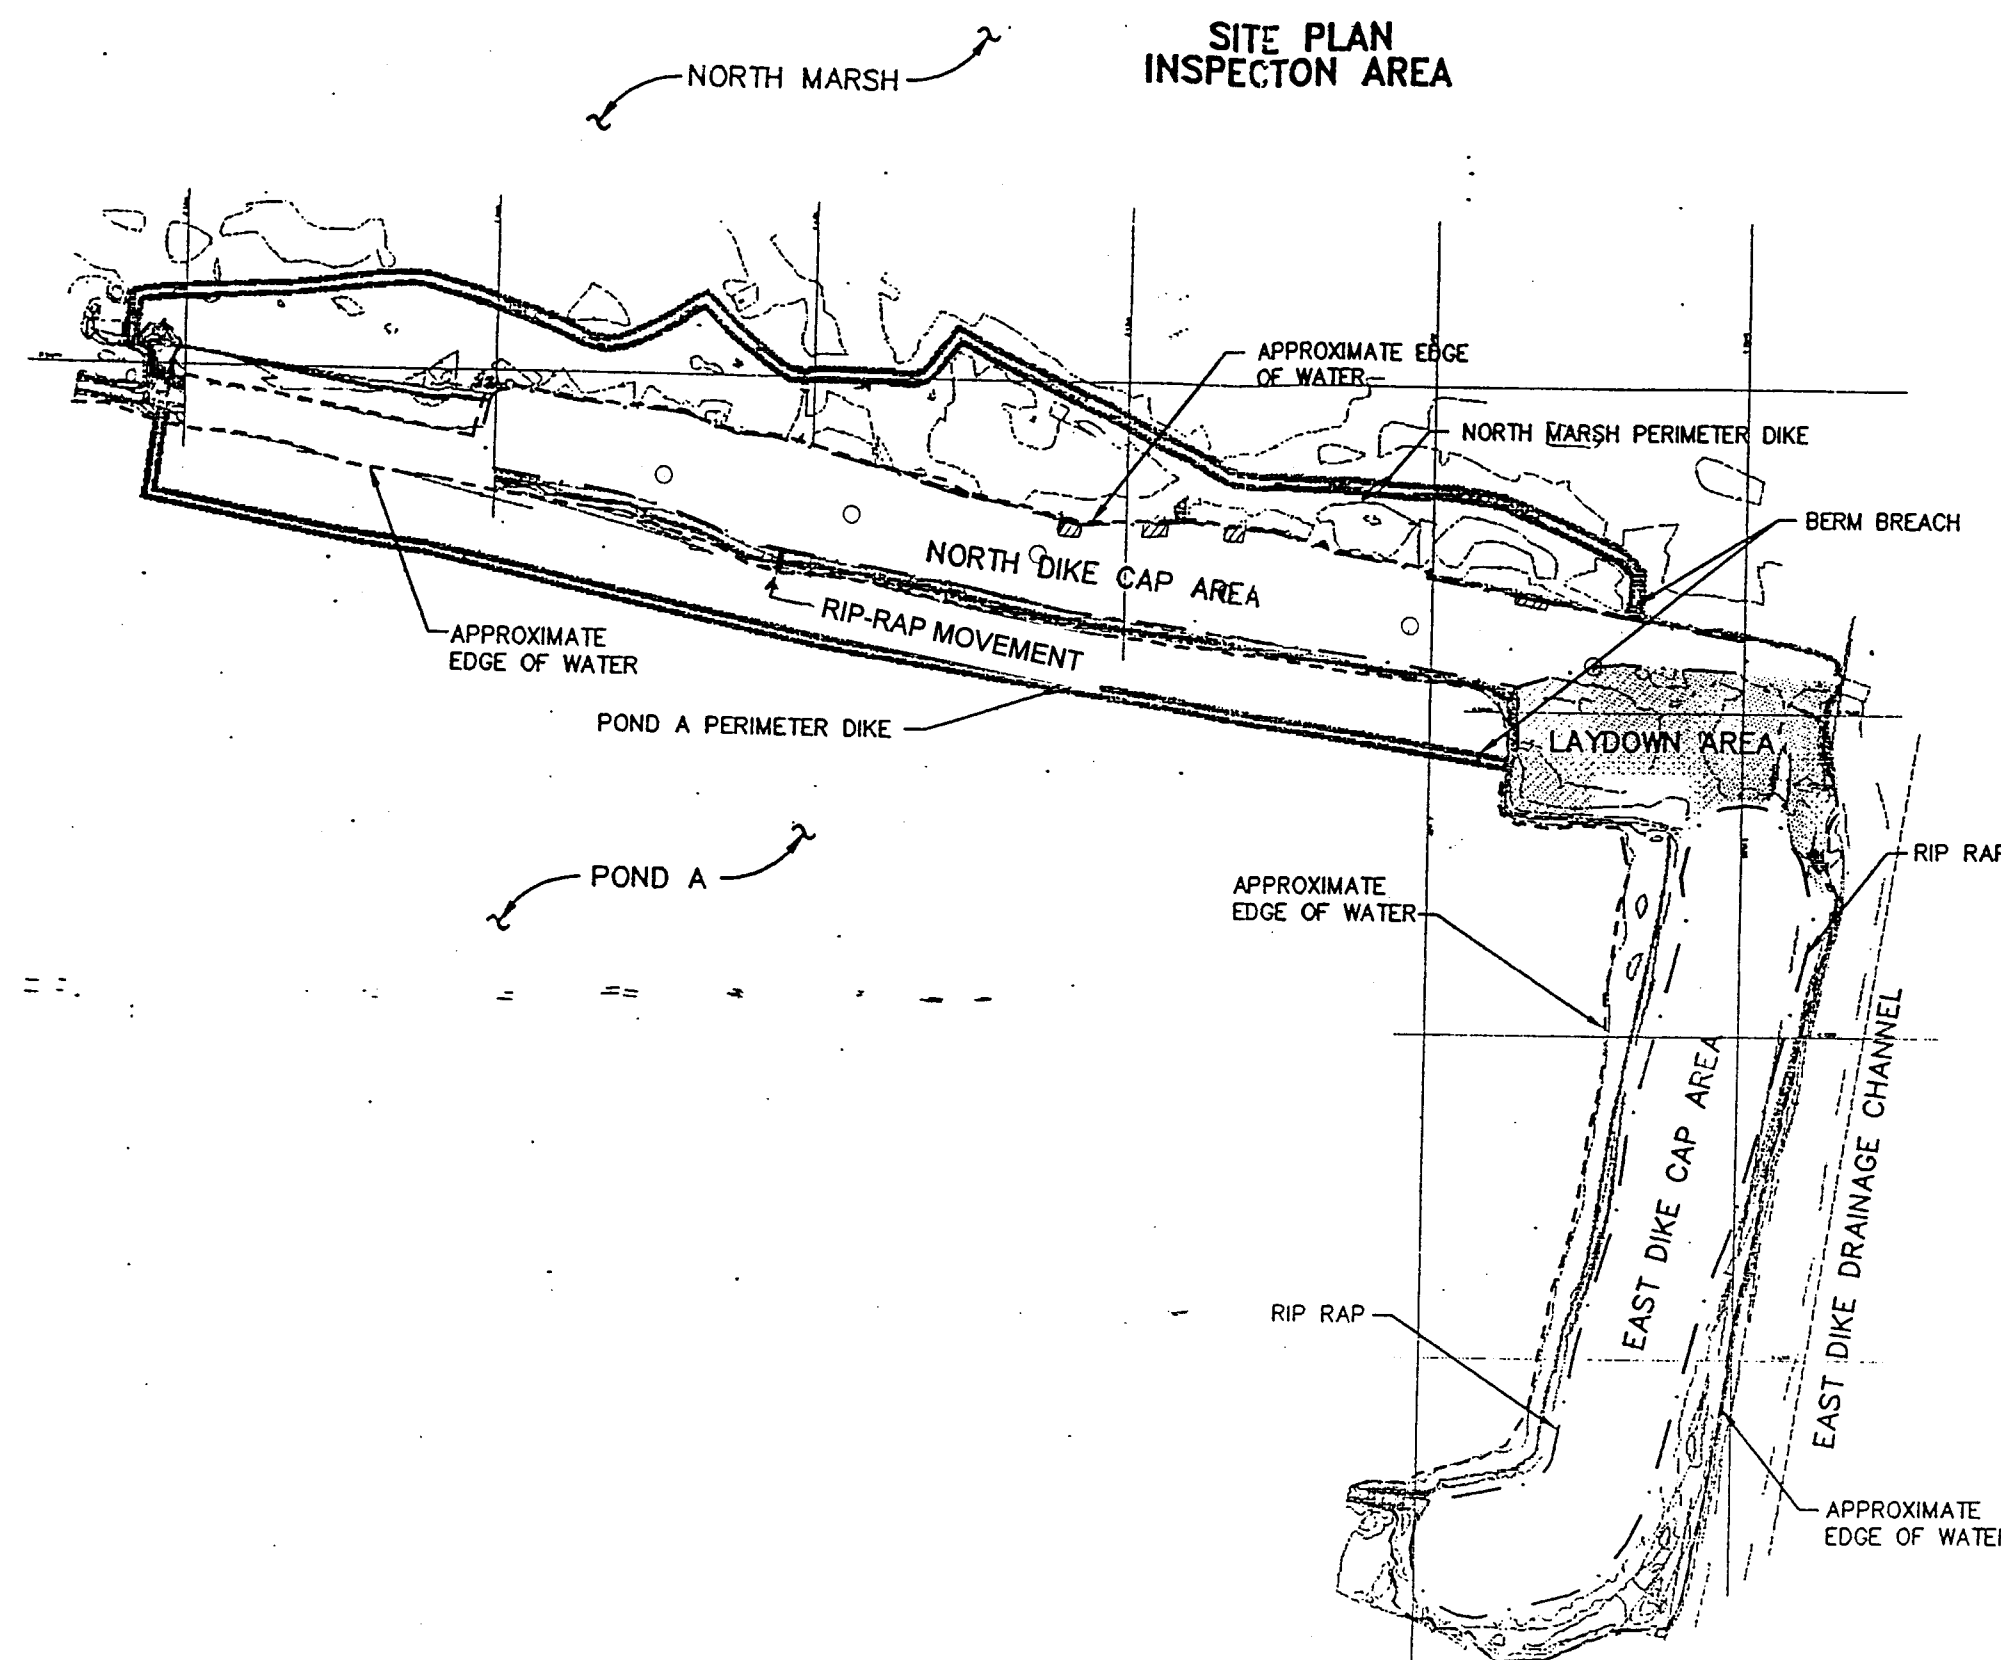
GeoSYNTEC CONSULTANTS ATLANTA, GA	
PROJECT NO. GE3913-620	FIGURE NO. 2.1
DOCUMENT NO.	FILE NO. 3913F004

- 4 areas noted of thin vegetation along the northern edge of the North Dike Cap. These areas are minimal in size. Recommend placement of hay bales.
- Rip rap, approx. 150 feet west of 5th vent on N. Dike Cap on southern side, shows signs of potential settling and/or movement due to stormwater runoff from the cap.
- We were unable to inspect the Pond A culvert but Pond A does not appear to have water condition problems.
- Sign missing on outer gate.
- Sign missing on east fence, just south of gate.
- Approach to bridge from east side (Hwy 87) needs more gravel to fill in gap between road & bridge.
- Weed control may be needed for on-site roads if weeds do not die during cooler weather.
- Two holes, one at vent 2 and one at vent 4, on the East Dike Cap need to be filled in with soil. Inspection of geosynthetic material should be completed before soil is placed in holes.

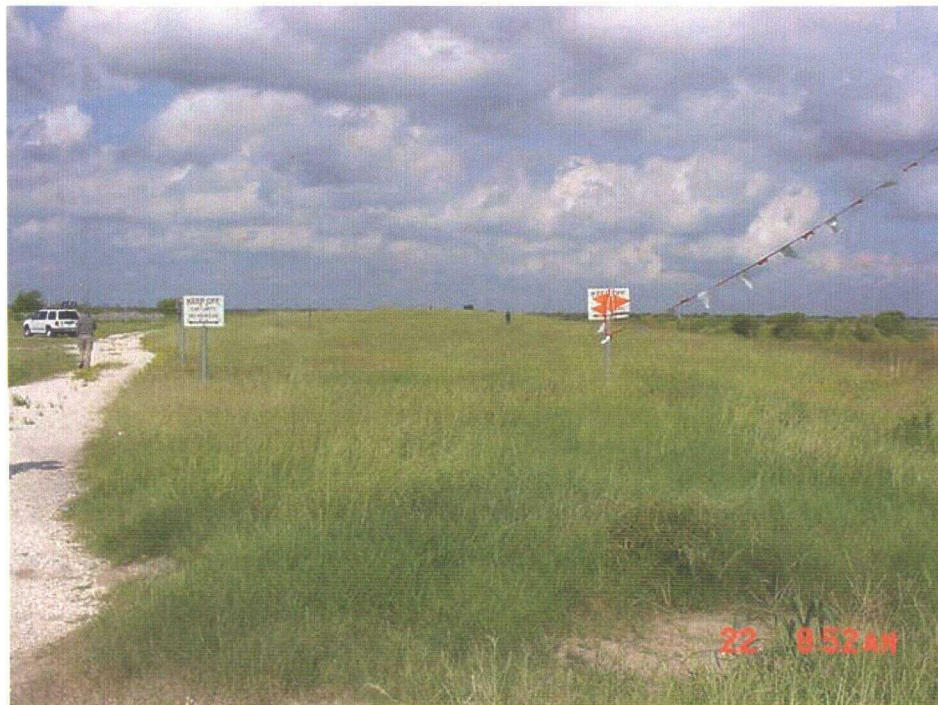
Photo 1: North Dike Cap looking west.

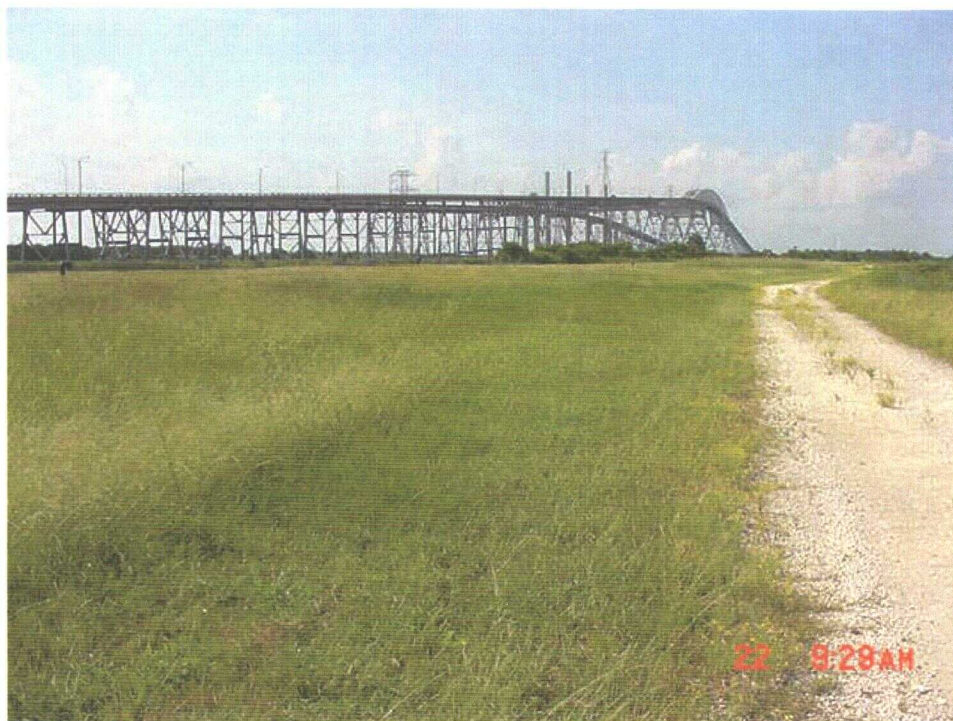
Photo 2: View of East Dike Cap illustrating healthy, dense grass growth.

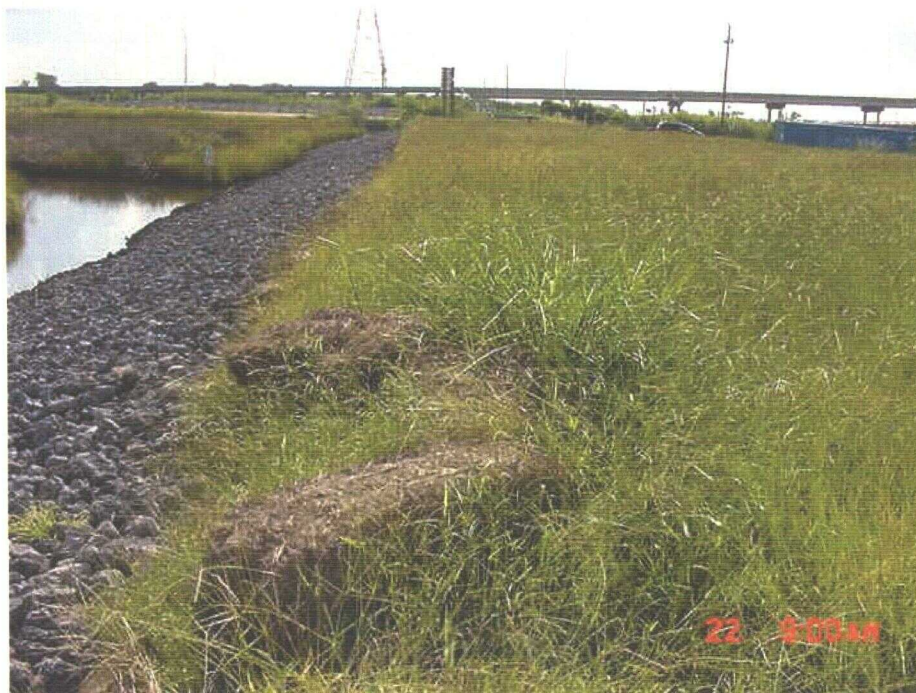
Photo 3: Edge on North Dike Cap with dense grass growth and hay bales.

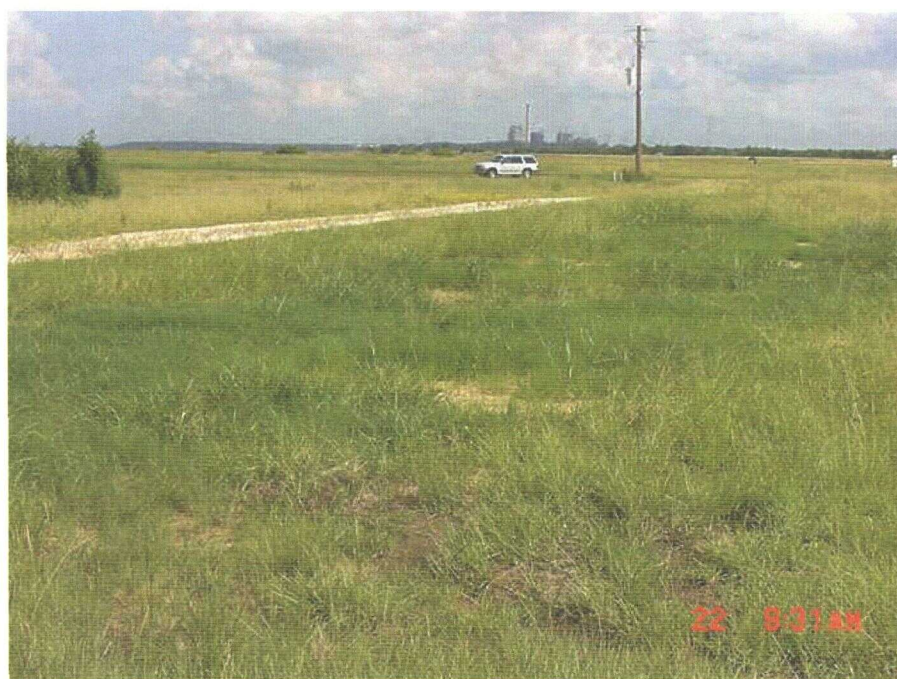
Photo 4: Area where new soil and grass seed were applied in mid June 2001. Grass has covered approximately 90% of bare soil.

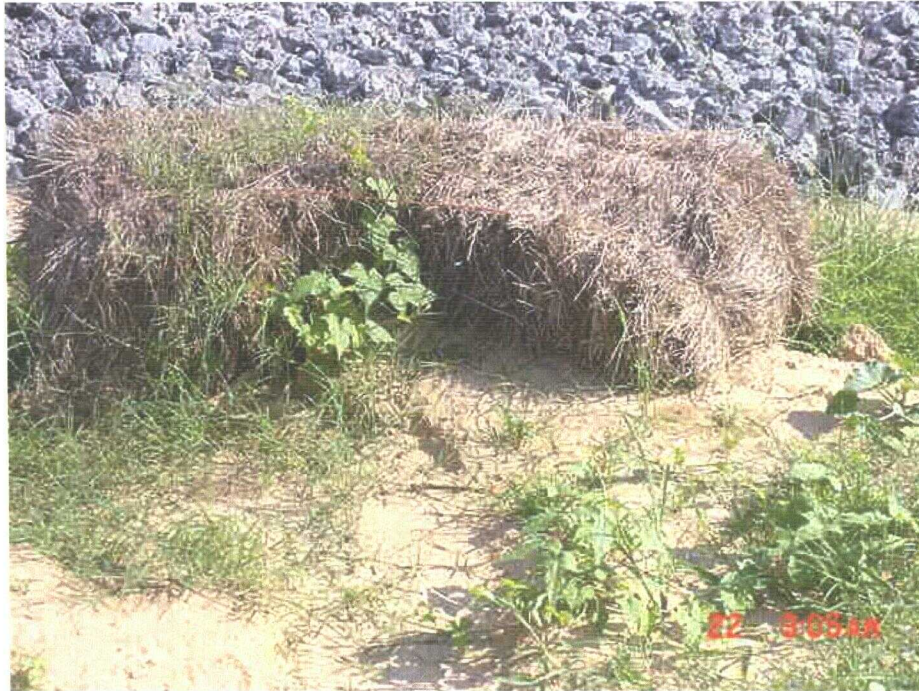
Photo 5: Hay bales effectively holding soil in place and preventing significant erosion on North Dike Cap.

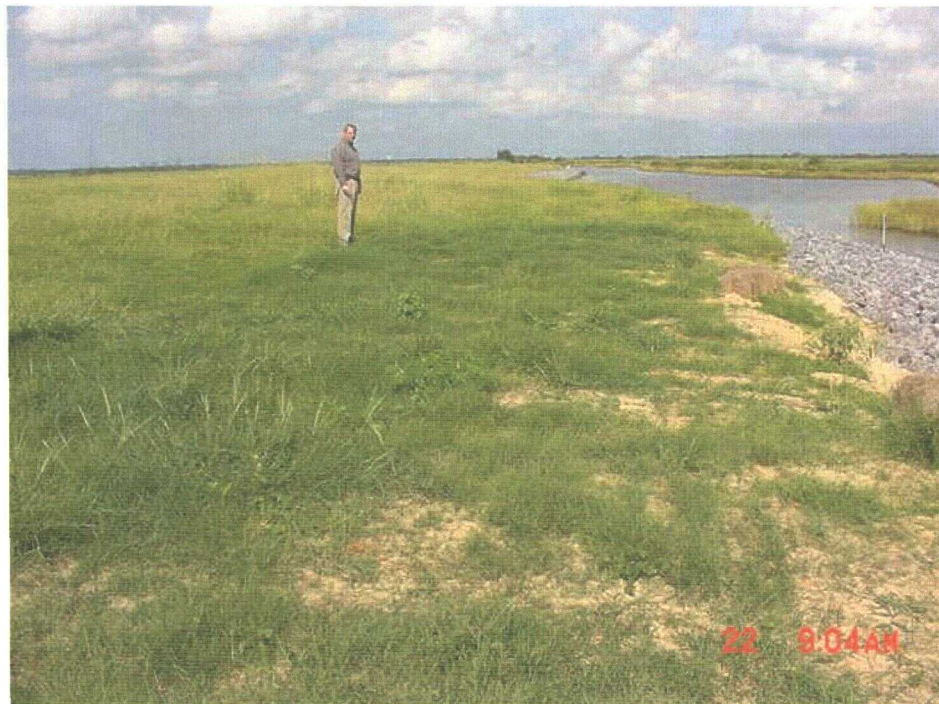
Photo 6: Area of new soil and grass growth (outlined in black) on the North Dike Cap. Soil and grass seed were placed in the middle of June 2001.

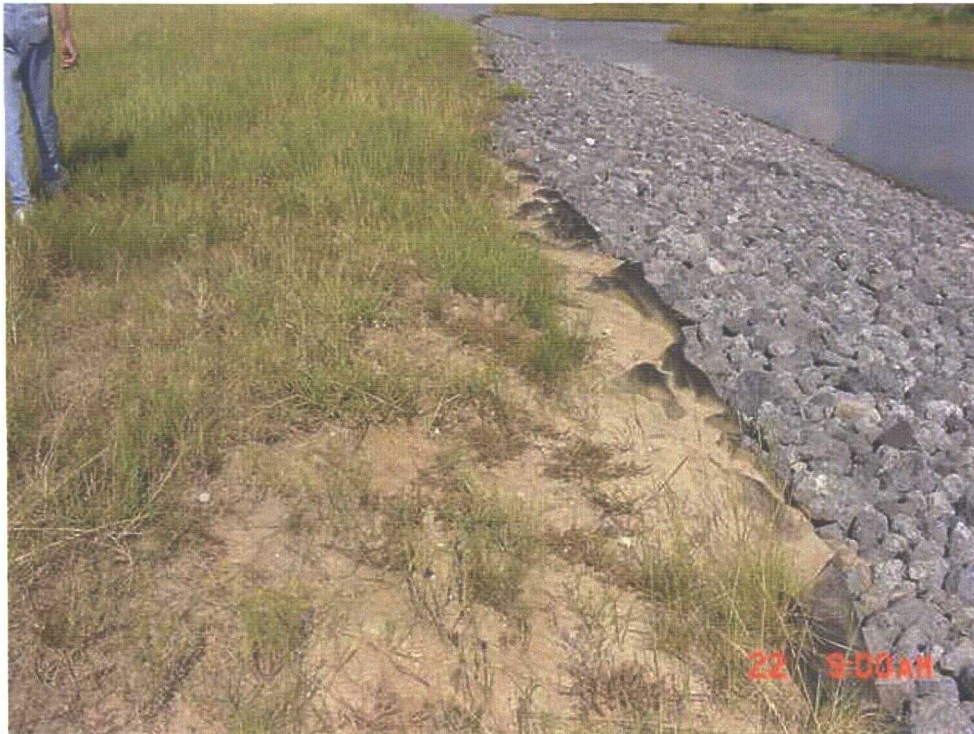
Photo 7: Small area of less grass growth on the North Dike Cap between the first and second gas vents (going east to west). New soil was placed here in June 2001.

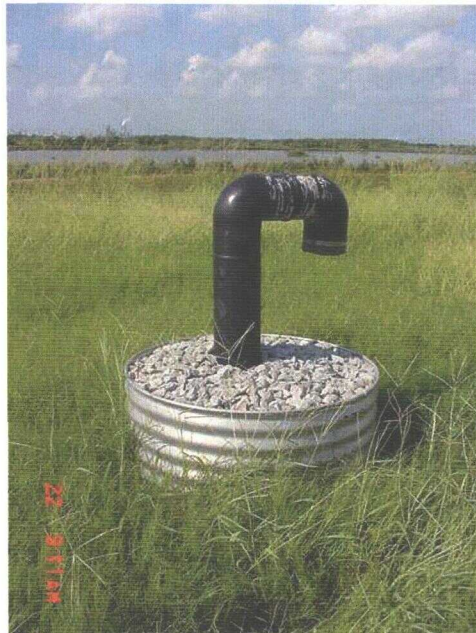
Photo 8: Gas vents are in good condition.

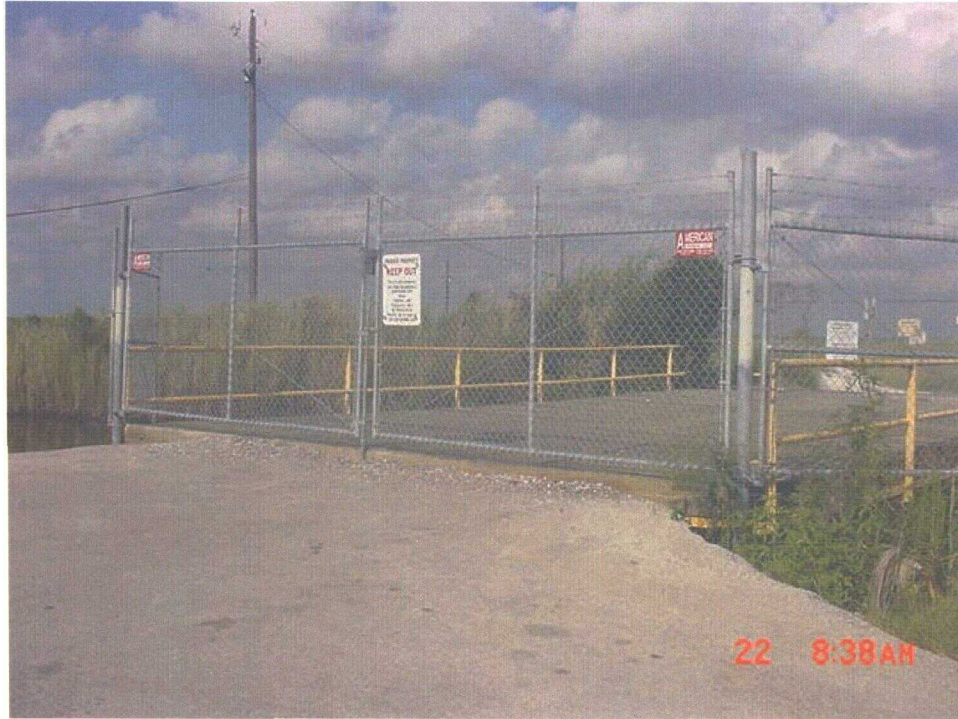
Photo 9: Main gate and bridge, looking west.

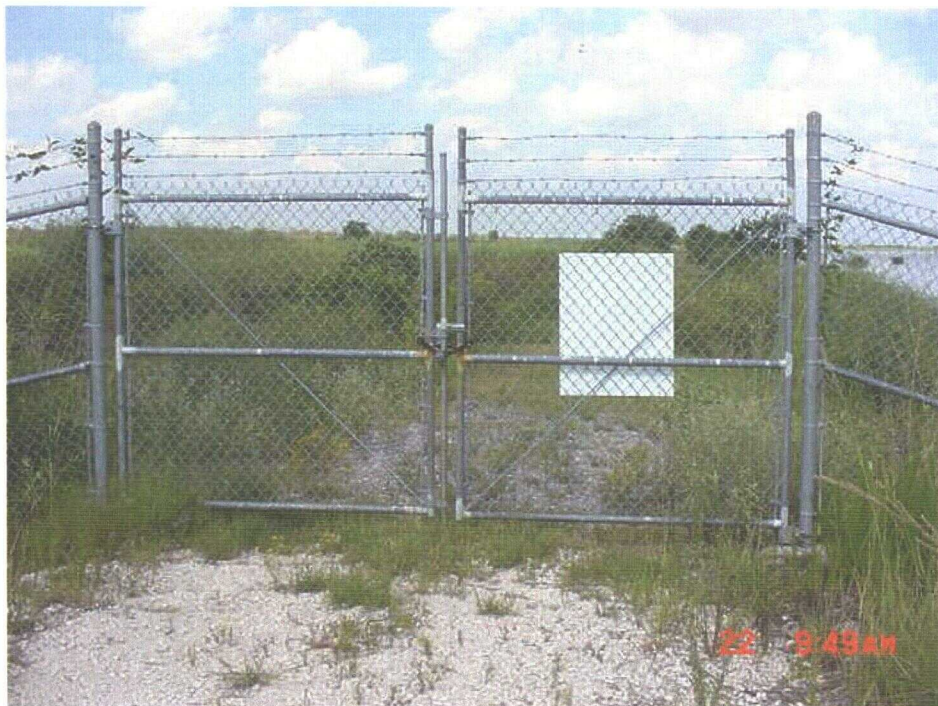
Photo 10: Back gate is locked and secure.

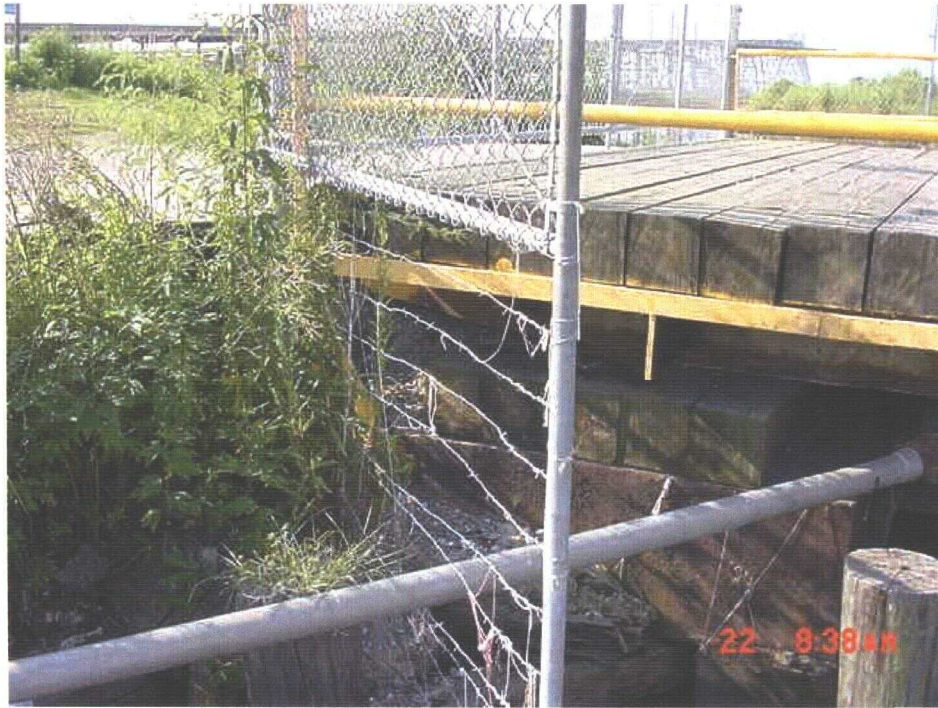
Photo 11: Structure of bridge at northeast corner.

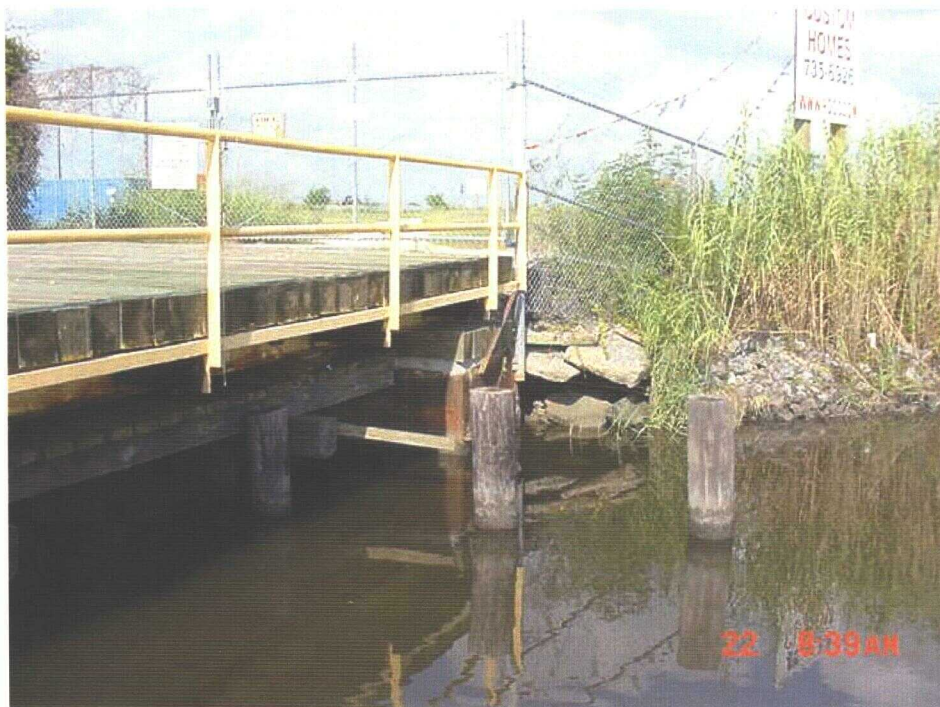
Photo 12: Structure of bridge at northwest corner.
